Vertical keypad replacement procedure for VR06/VR18

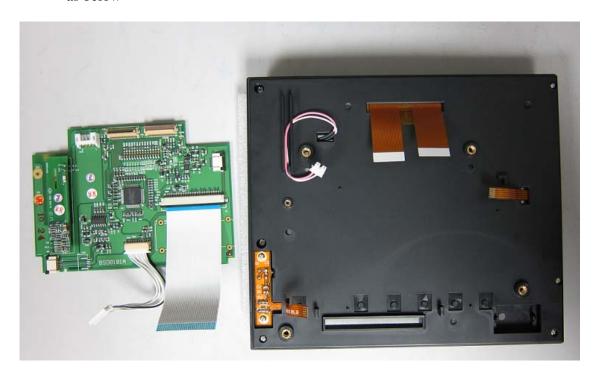
4. Now, display board BSDB181A will be removed from LCD module and appears as below

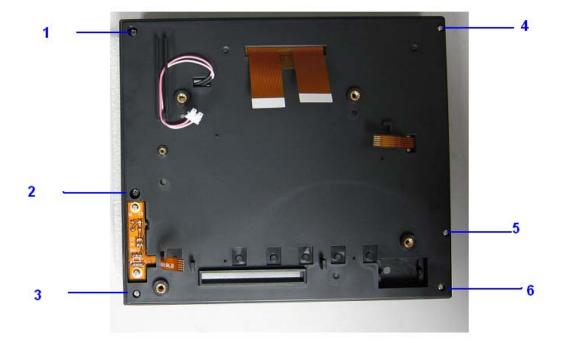
5. Now, remove 6 screws from the LCD module. All of them are not of same size. Please do remember the screw size and their locations carefully.

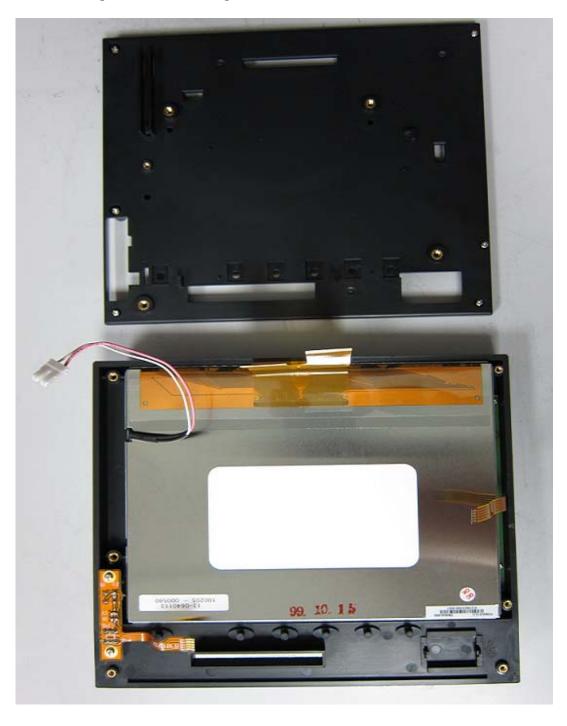
6. Now, pull the black color plate outside

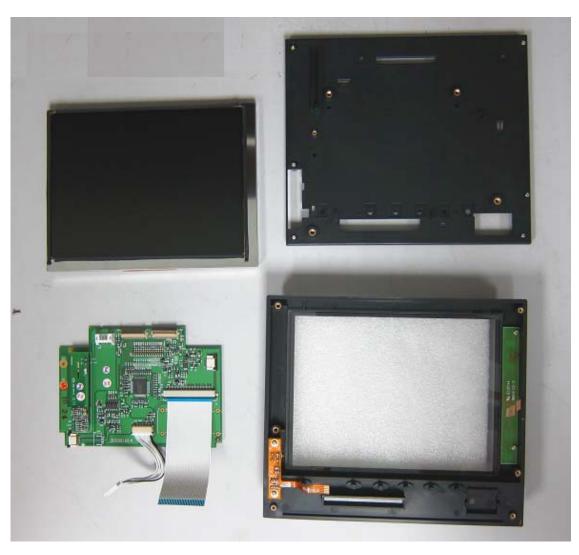
8. Then, it appears as follows

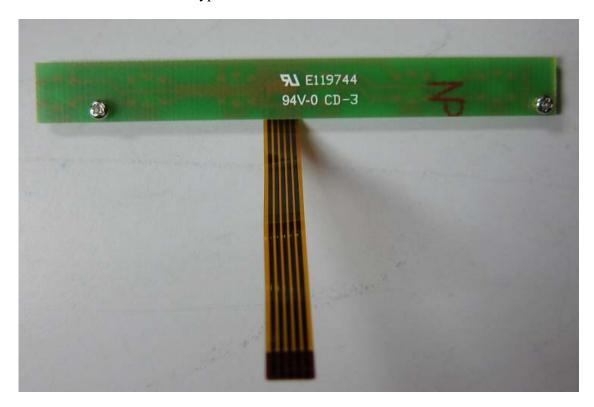
9. This is the vertical keypad

10. Remove the faulty vertical keypad and replace with new one
